Manhole Inspection Summary

Manhole # S29II_006MH

Insp Date: **4/9/07 11:36 AM**

Location Address: **1520 PARK AVE** Cross Street: **McMECHEM ST**

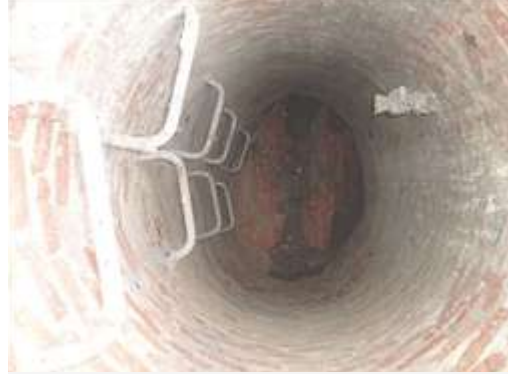
Top View

Channel debris.

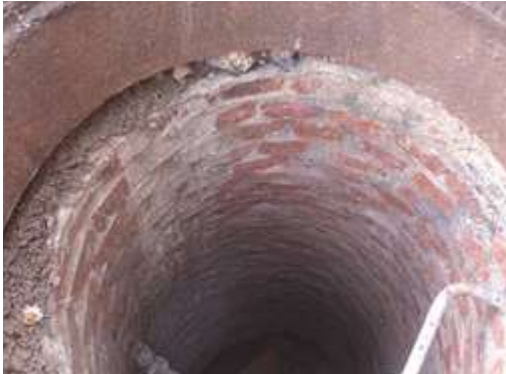
Defect

Frame leaks. Frame offset. Adjustment deterioration and infiltration. Corbel and Barrel infiltration.

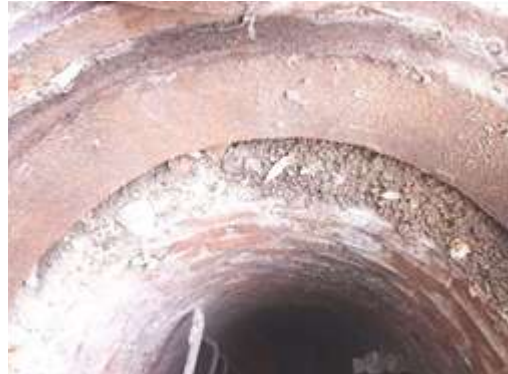
Defect

Frame leaks. Frame offset. Adjustment deterioration and infiltration. Corbel infiltration.

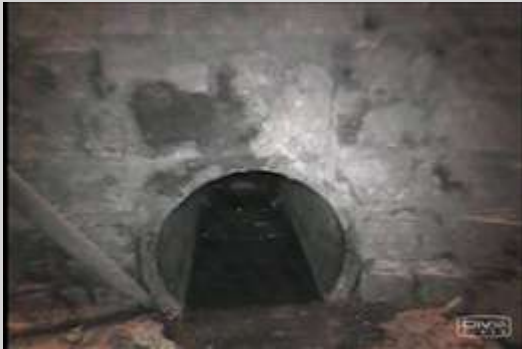
8 in. Circular Gravity Sewer
Pipe Out @ 12 O'Clock

Barrel infiltration.
